## Case Study: Centrifugal pump in an iron manufacturing plant

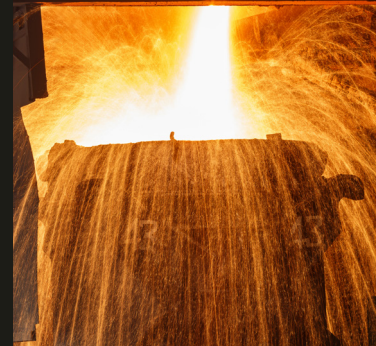
Using the existing packing solution in aggressive contaminated water conditions with abrasive particles of iron dust coming from blast furnace, the customer experienced frequent packing failures (on a weekly basis) due to mechanical damage and chemical attack. This resulted in an unacceptable leakage rate and excessive maintenance and replacement costs.

The use of Lionpak® 2506 enables the customer to significantly increase packing service life, now reported as up to 3-4 months. As the product can withstand operation in a chemical and abrasive environment significantly longer than general service packing, the customer is able to realise improved efficiencies and reduced maintenance efforts.

To overcome the harsh environment, Lionpak® 2506 was supplied. A high performance packing made of ePTFE/graphite yarn at the face reinforced with carbon fibre at four corners, this solution is a very cost effective packing highly recommended for pumps handling chemical slurries, contaminated water, industrial water, effluent, bauxite slurries, bottom ash slurries and other slurries.
